Site office, gantry and retained façade.  
Combined support structures

Building no.1 - Retained Facade

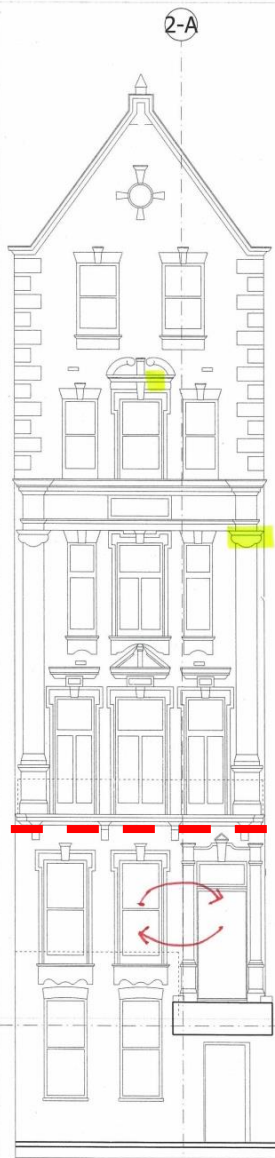
01 EXISTING FACADE  
11060\_E\_SW\_1412\_1.DWG

MAIN AREA OF BRICKWORK  
REPLACEMENT AS  
SUGGESTED IN  
"DILAPIDATION REPORT"  
BY HANSON.

EXISTING DOOR & WINDOW  
POSITIONS TO BE SWAPPED.  
NEW BRIDGE TO BE  
INTRODUCED

1170 FACADE DEPTH  
INCREASE

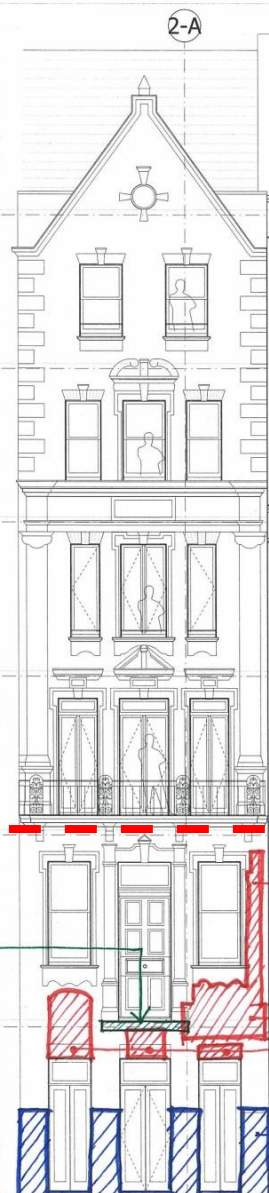
02 PROPOSED FACADE  
11060\_E\_SW\_1410\_1.DWG

EXISTING DOOR & SURROUND REMOVED.  
FILLED WITH NEW BRICKWORK.  
EXISTING BRIDGE REMOVED.

EXISTING WINDOWS & BRICK ARCHES  
TO BE REMOVED. NEW BRICKWORK  
INFILL TO BE INTRODUCED.

EXISTING BRICKWORK REMOVED.  
WHITE RENDER FINISH TO BE  
APPLIED ON RC UPSTAND.

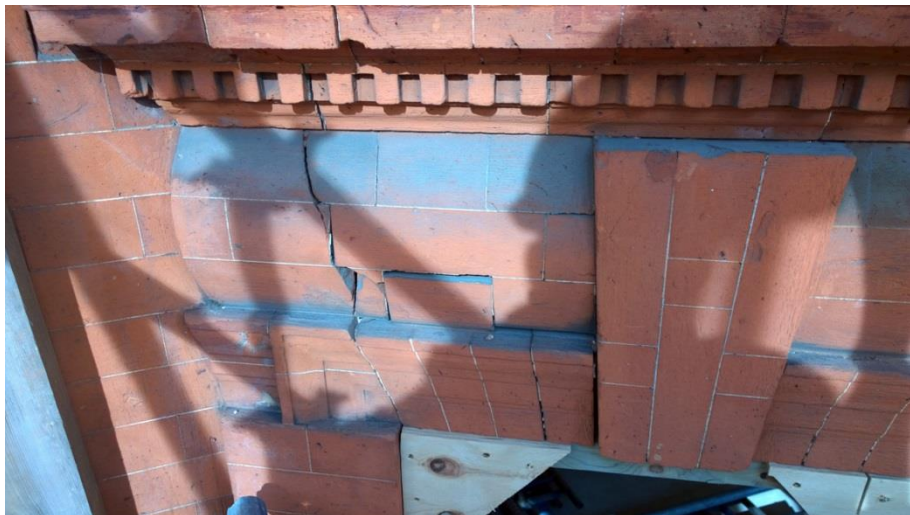
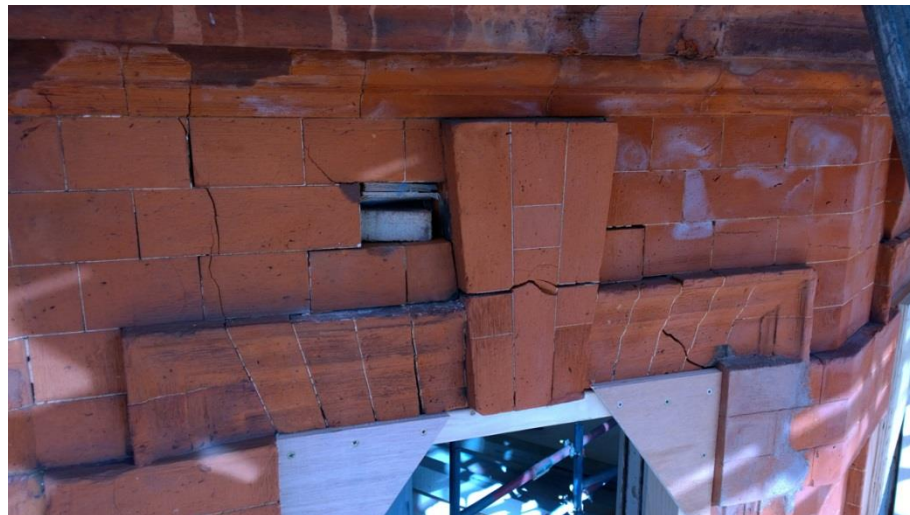
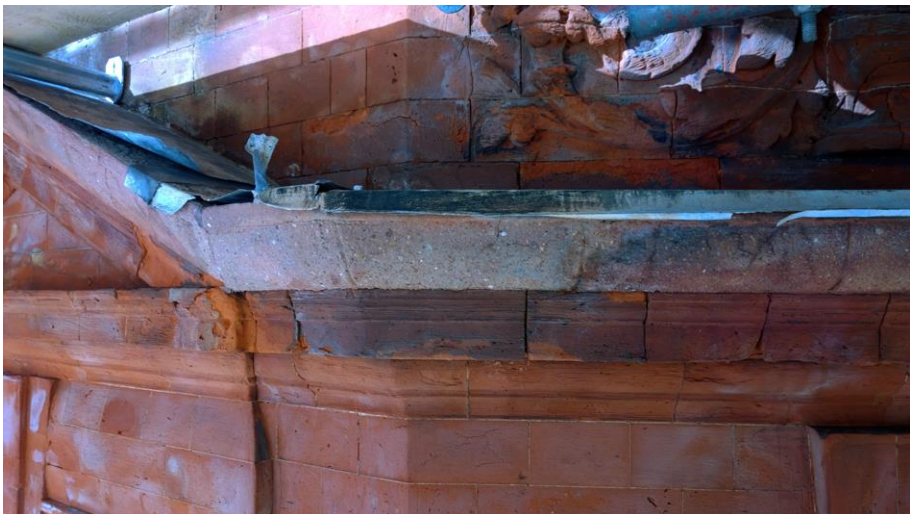
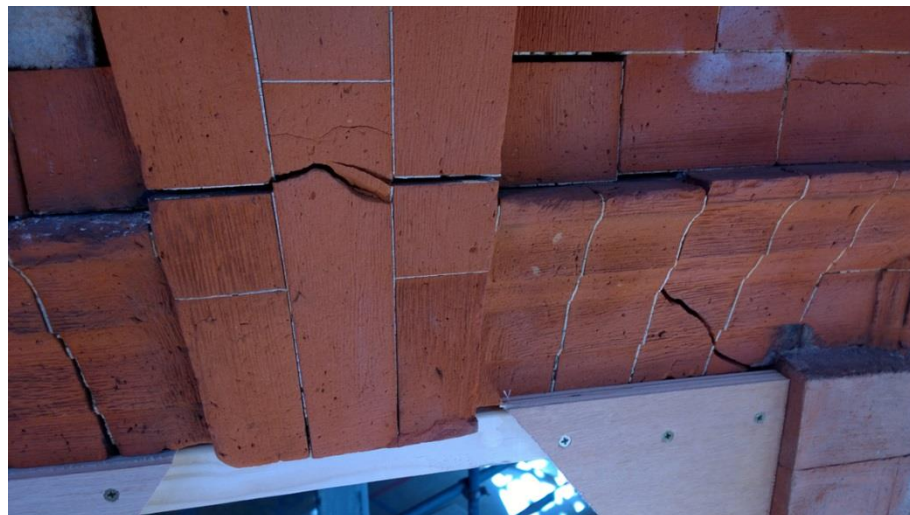
Building no.1 - Retained Façade Failure: Slippage + Movement

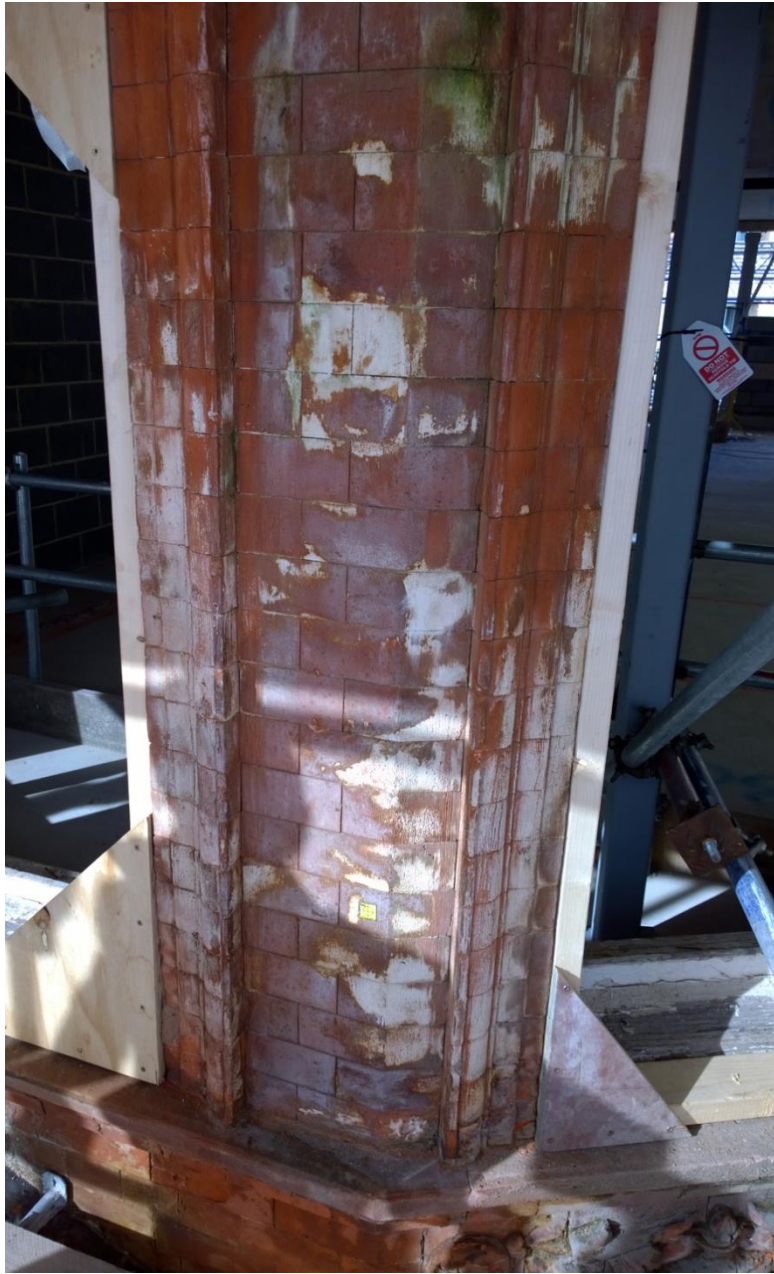
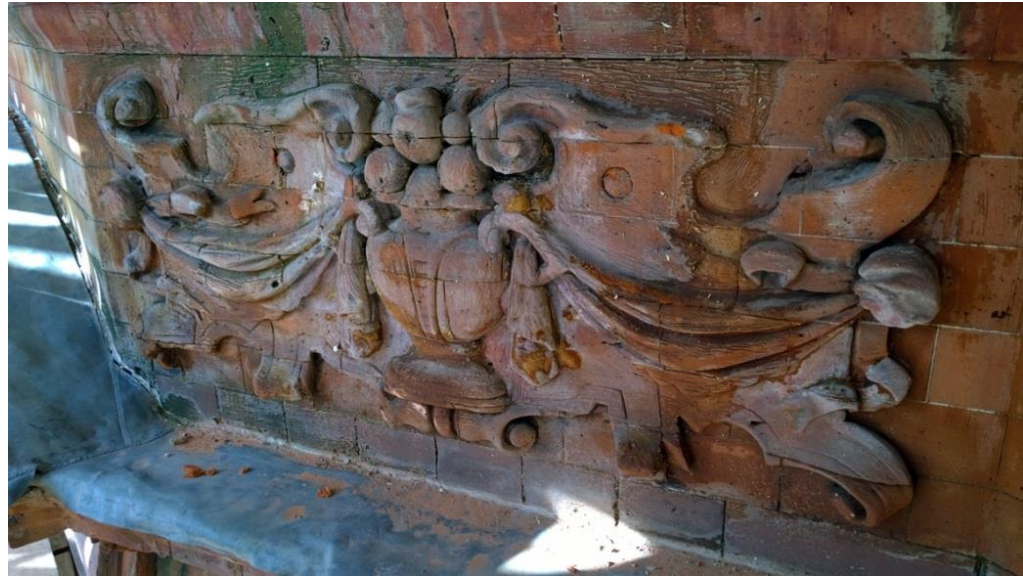
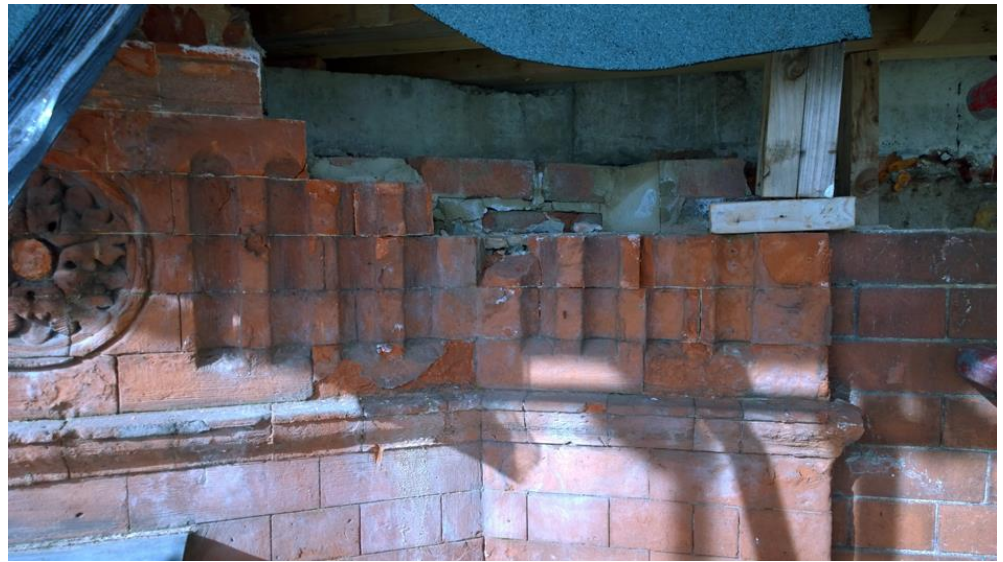
Building no.1 - Retained Façade Failure: Spalling (water ingress)

- Pre 2012 damage - replacement
- Rebuild (consented)
- Material failure
- Additional removal to replace material failure
- Cosmetic (some replacement)

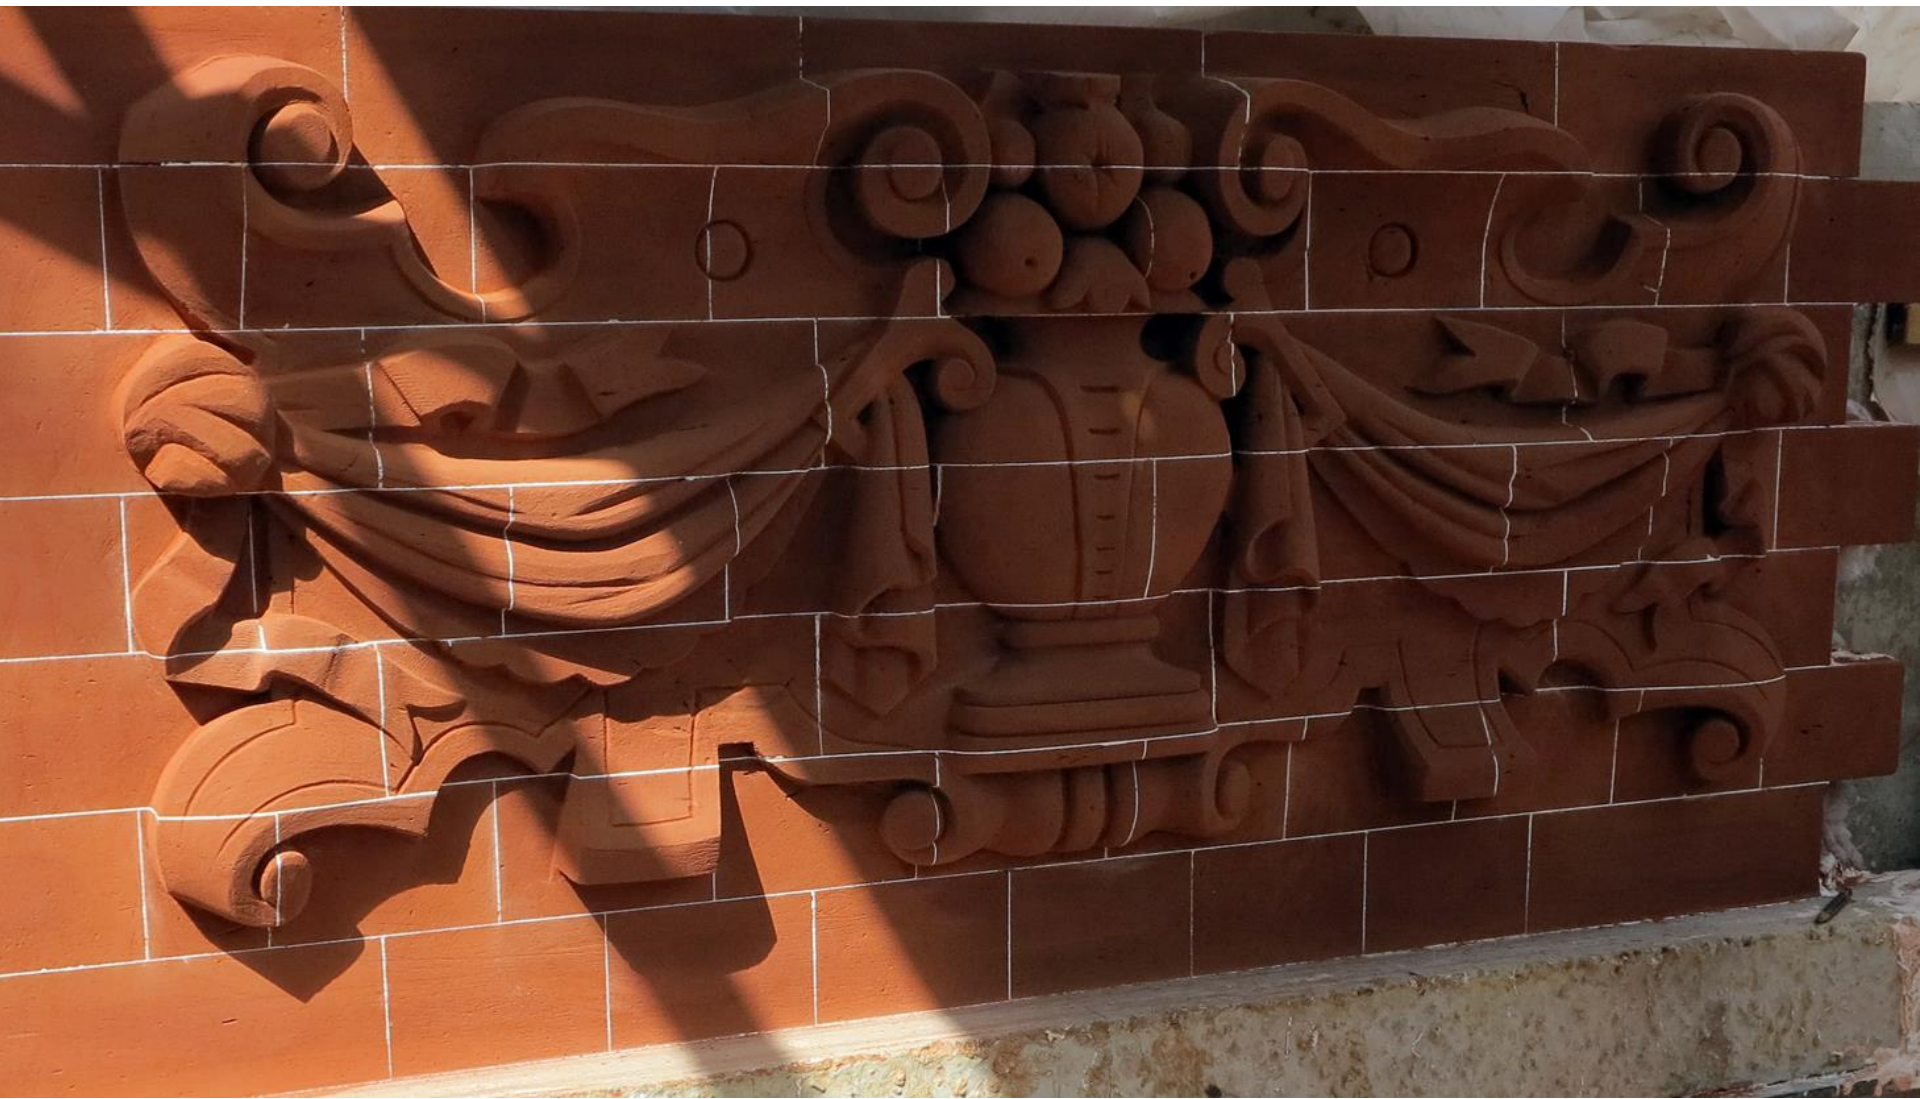
Replica sample panel

High and low levels  
at recess point

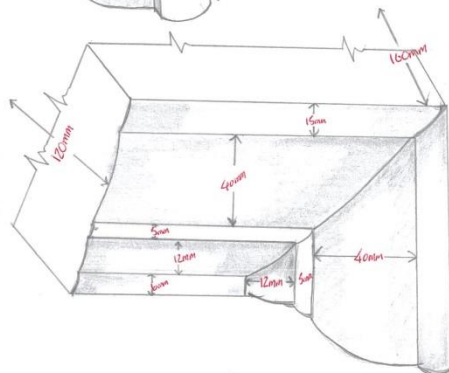
Corner bricks to the  
arches at ground  
floor house 53

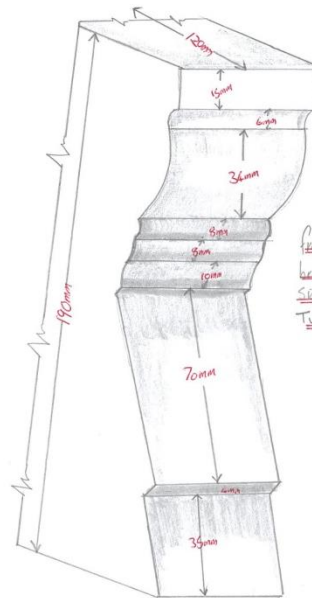
front view arch  
brick 1/4 and R/H  
Side same  
Type 58

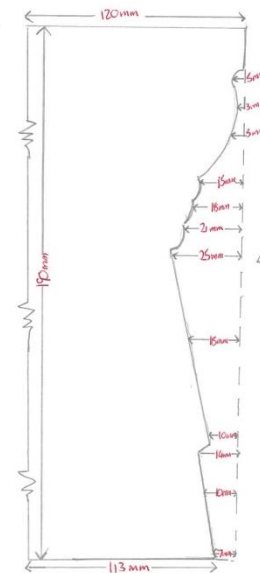
Side view arch  
brick dotted line  
Denottes face of  
brick to be carved  
Type 58
