Site office, gantry and retained façade.  
Combined support structures

Building no.1 - Retained Facade

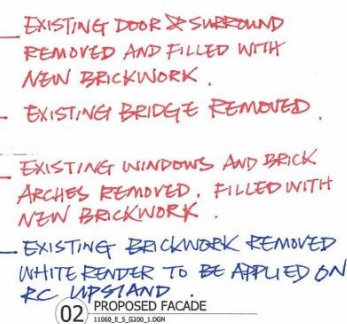
MAIN AREA OF BRICKWORK  
REPLACEMENT AS  
SUGGESTED IN  
"DILAPIDATION REPORT"  
BY HANSON.

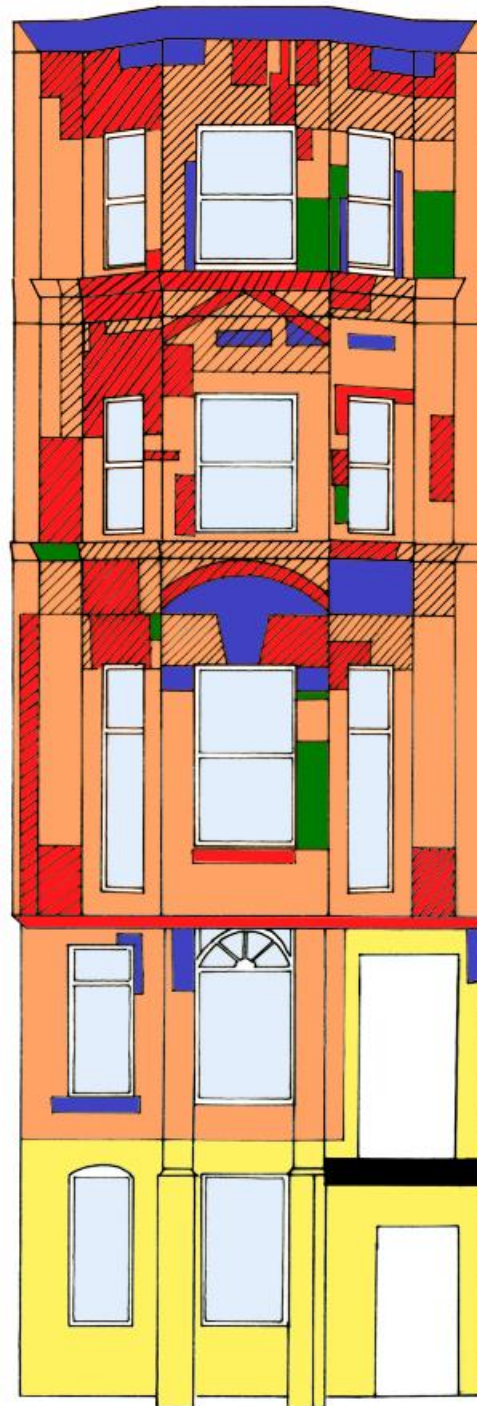
- Pre 2012 damage - replacement
- Rebuild (consented)
- Material failure
- Additional removal to replace material failure
- Cosmetic (some replacement)
